Permanent Buried Reference Electrodes: Technical Note on Significant Inaccuracies and Medium Term Trials

Brian S Wyatt Eur Ing, BSc (Hons), CEng, MIMMM, FICorr, FCS
Corrosion Control, 3 Ivy Court, Acton Trussell, Staffordshire ST17 0SN, UK

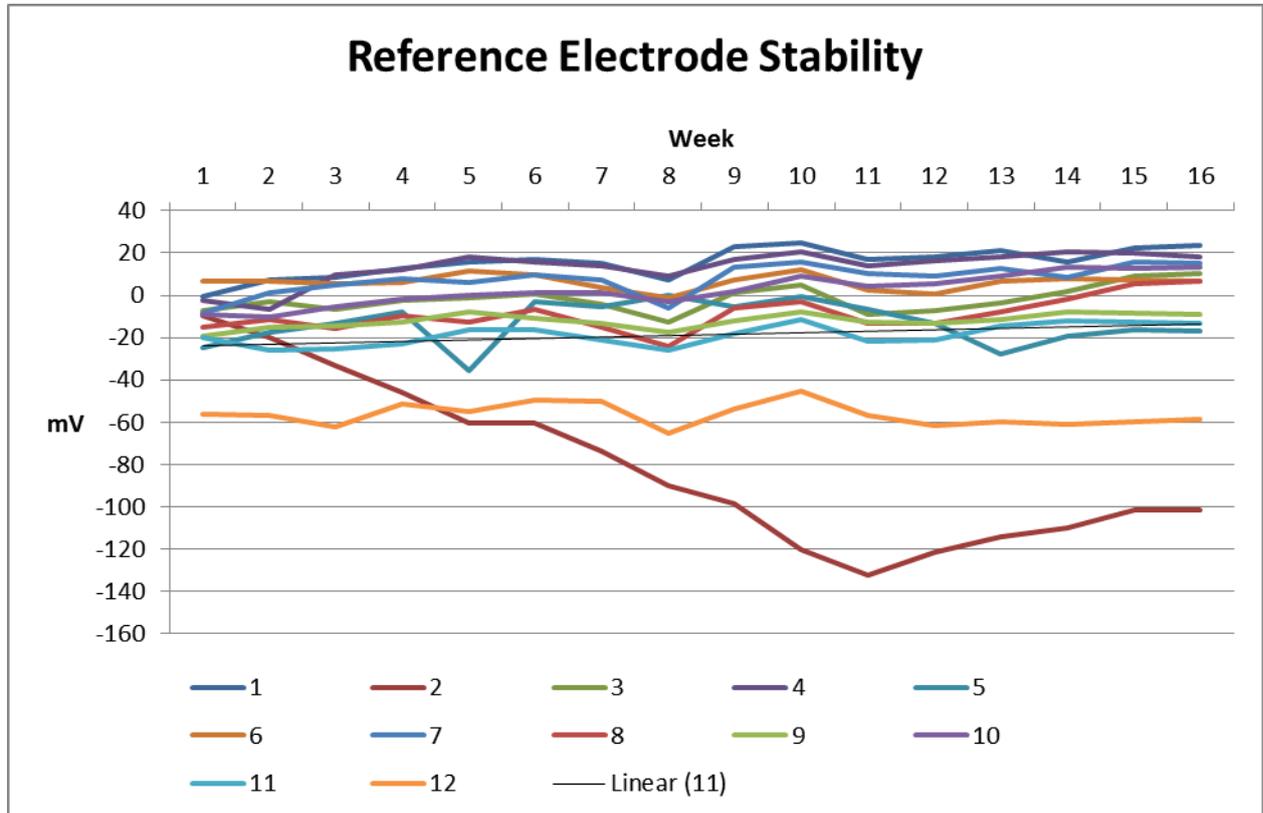
Figure 1: Permanent Reference Electrode Potential vs Calibrated Portable Electrode (500mm spacing at same depth) at same site. Weeks are not linear: “Week 16” is actually after 28 weeks of trial. The Ag/AgCl/0.5M KCl electrode is corrected to Cu/CuSO₄ equivalent by 40mV. It is series 10

12 No. electrodes were tested, and continue to be tested, with data currently at 28 weeks after installation showing, of the 12 No. electrodes tested from the 8 No. manufacturers, one was in error by >130mV. The least accurate electrode was not from the originally selected manufacturer whose electrodes showed errors of approximately -200mv to +130mV as in Table 1 above. The electrode of the same type as deployed along the pipeline in 2012 was in error by >60mV at the test site.

The 2 No. simple “old fashioned” porous pot electrodes were amongst the best performing electrodes with one showing a maximum error of +25mV and the other +21mV. Both of these would have presented dimensional problems for the optimum method of installation.

Only 5 No. of the 12 No. electrodes were accurate to +/- 20mV of their theoretical potential (which was assessed to include a maximum of 10mV soil potential gradient "error").

The Ag/AgCl/0.5M KCl electrode which was included in the testing (converted to Cu/CuSO₄ by a debateable 40mV conversion factor) was accurate throughout the trials to within 14mV (which was assessed to include a maximum of 10mV soil potential gradient "error").

The full data sets, anonymised, are presented in Figure 1.
